| Title | Direct observation of changes in the effective minority-carrier lifetime of SiNx-passivated n-type crystalline-silicon substrates caused by potential-induced degradation and recovery tests |
| Citation | Microelectronics Reliability, 79: 91-95 |

# Direct observation of changes in the effective minority-carrier lifetime of SiN<sub>x</sub>-passivated n-type crystalline-silicon substrates caused by potential-induced degradation and recovery tests

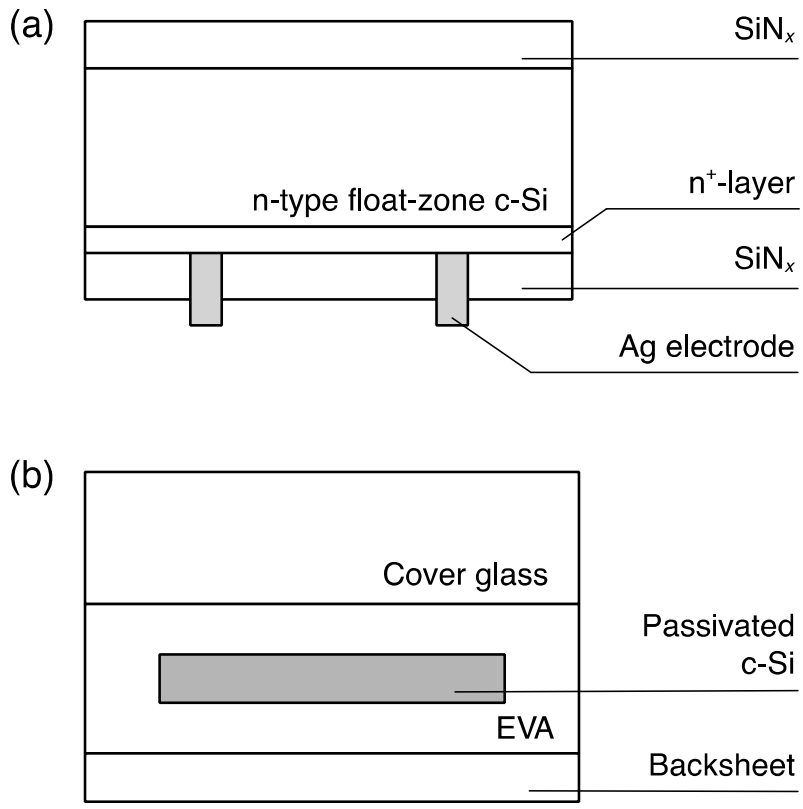
Fig. 1.

**Fig. 1.** Structures of (a) the passivated and screen-printed n-type c-Si substrate samples and (b) the module-like encapsulated samples (not to scale).

We prepared samples schematically illustrated in Fig. 1(a) to clarify the effects of PID stress on the  $\tau_{\text{eff}}$  of n-type c-Si-wafer-based PV cells including RE n-type c-Si PV cells. These samples involved both-side  $\text{SiN}_x$  passivation films and an n-type float-zone c-Si substrate. 4-inch,  $\sim 300\text{-}\mu\text{m}$ -thick, phosphorus-doped c-Si wafers with a resistivity of 1–5  $\Omega\cdot\text{cm}$  and a bulk minority-carrier lifetime of  $>10$  ms were cleaved to  $20 \times 20\text{-mm}^2$ -sized substrates. After the standard RCA cleaning of the substrates, their rear sides were coated with a liquid phosphosilicate glass (PSG) source (Tokyo Ohka Kogyo SC-913) by spin coating, and the substrates were subsequently annealed at 850 °C for 25 min in  $\text{N}_2$  atmosphere to form  $\text{n}^+$ -doped layers. These rear  $\text{n}^+$  layers were formed to easily provide Ohmic contact to screen-printed silver electrodes. Posterior to the removal of remaining PSG layers, we deposited  $\text{SiN}_x$  films with a thickness of  $\sim 75$  nm and a refractive index of  $\sim 2.0$  on the both sides of the substrates by catalytic chemical vapor deposition (Cat-CVD) [18, 19]. Cat-CVD  $\text{SiN}_x$  films were deposited at  $\text{SiH}_4$  and  $\text{NH}_3$  flow rates of 8 and 300 sccm, respectively, at a pressure of 15 Pa, and at substrate holder and catalyzer temperatures of 300 and  $1800\pm 50$  °C, respectively. Their thickness and refractive index were determined by ellipsometry using the 632.8 nm line of a He-Ne laser. We conducted screen printing of silver pastes on the rear  $\text{n}^+$  layers, followed by firing through in a tube furnace at 800 °C to provide Ohmic contact to the substrates.

Interconnector ribbons were soldered onto the busbar of the silver electrodes. Fabricated were stacks composed of conventional tempered cover glass/ethylene-vinyl acetate copolymer (EVA) encapsulant/passivated c-Si/EVA encapsulant/backsheet [poly(vinyl fluoride) (PVF)/poly(ethylene terephthalate)/PVF], where the “passivated c-Si” means the sample passivated with both-side  $\text{SiN}_x$  as shown in Fig. 1(a). Module-like structures schematically illustrated in Fig. 1(b) were fabricated by laminating the stacks in a module laminator. Our lamination process consisted of two steps: a degassing step for 5 min and an adhesion step for 15 min. The stacks were placed with the cover-glass side down on a stage maintained at 115 °C during lamination. The PID tests for module-like samples shown in Fig. 1(b) were performed by applying a negative bias of  $-1000$  V or a positive bias of

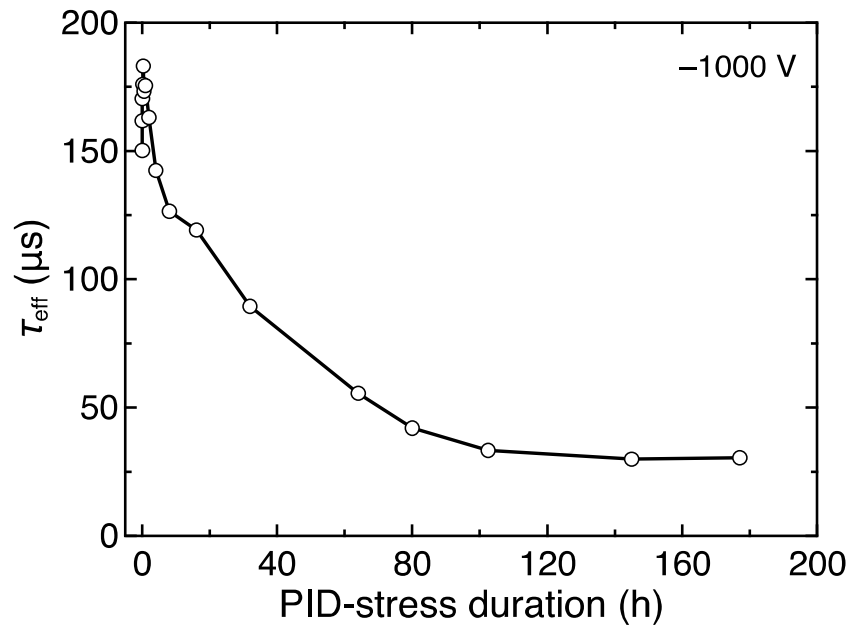
Fig. 2.

**Fig. 2.** Dependence of the  $\tau_{\text{eff}}$  of the samples on PID-stress duration. The voltage was set to  $-1000$  V. The data points are the mean values for three samples.

Shown in Fig. 2 are changes in the  $\tau_{\text{eff}}$  of the investigated samples subjected to PID-tests in which a negative bias of  $-1000$  V was applied. The  $\tau_{\text{eff}}$  first increases rapidly, then gradually decreases with increasing PID-stress duration, and seems to saturate within around 110 h. Generally, negative biases with respect to the cover glass lead to sodium (Na) introduction into PV cells and positive charge accumulation in the front passivation films. In this case, the latter is not detrimental because positive charges in the front passivation films repel minority carriers—holes—away from the surface and rather should improve the  $\tau_{\text{eff}}$  of the samples. The  $\tau_{\text{eff}}$  improvement observed in the initial stage of the PID test is probably related to the positive charge accumulation in the  $\text{SiN}_x$ . The successive degradation of  $\tau_{\text{eff}}$  should be correlated with the former phenomenon—Na introduction. The degradation behavior seems to be qualitatively consistent with that of the  $V_{\text{oc}}$  of RE n-type c-Si PV modules undergoing PID [10]. According to previous studies regarding PID in conventional p-type c-Si PV modules [21–23], Na positive ions pass through the front  $\text{SiN}_x$  passivation films, induce the formation of stacking faults in the surface region of the Si layer, and simultaneously decorate the stacking faults, with assistance from a negative bias. These Na-decorated stacking faults behave as shunts when they intersect the p–n junction interface [21, 22]. In RE n-type c-Si PV modules, such Na-decorated stacking faults, on the other hand, do not behave as shunts because these cells have no p–n junction on the front side. Instead, these Na-decorated stacking faults can act as additional recombination centers in RE n-type c-Si PV modules; thereby, their  $V_{\text{oc}}$  are reduced [10,

24]. A similar model has been proposed to explain PID in n-type IBC c-Si PV cells [11]. The  $\tau_{\text{eff}}$  reductions observed in our samples are consistent with these proposed hypotheses and can explain the reason behind reductions in the  $V_{\text{oc}}$  in prior studies [10, 11]. As for the saturation behavior, it has been reported that the PID of RE n-type PV modules tends to saturate [10], and thus, the saturation behavior in the lifetime reduction appears to be consistent with the previous results; however, duration needed to saturate the  $\tau_{\text{eff}}$  reduction largely differs from that needed to saturate  $V_{\text{oc}}$  reductions. A possible reason for this is that there are differences in the properties of  $\text{SiN}_x$  films and/or c-Si substrates. We should also mention that Na ions tend to accumulate at  $\text{SiN}_x/\text{Si}$  interface under negative-bias PID stress in conventional p-type PV modules [21, 22]. The same phenomenon probably occurs also in our samples used in this study, which can be another reason for the enhancement in the surface recombination of minority carriers.

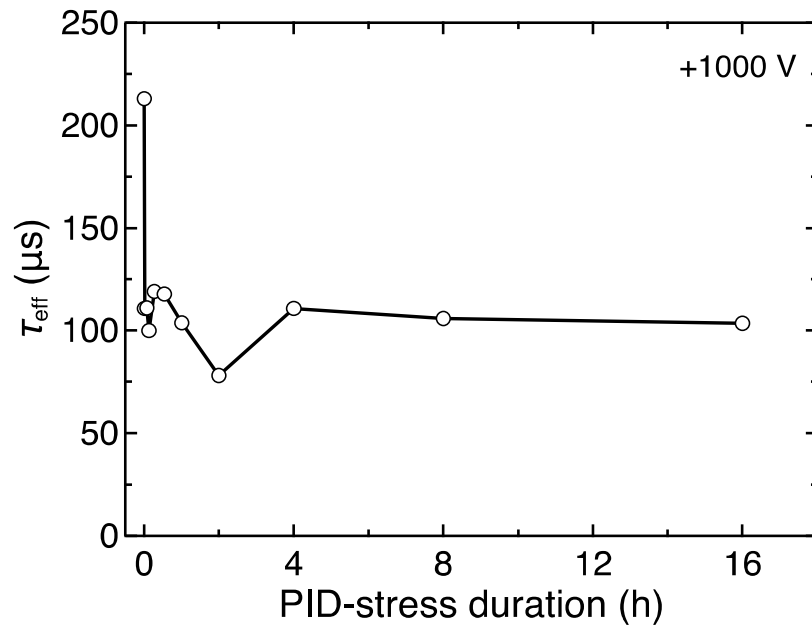
Fig. 3.

**Fig. 3.** Dependence of the  $\tau_{\text{eff}}$  of the sample on PID-stress duration. The voltage was set to  $+1000$  V. These data points were obtained from measurements for the one sample.

Fig. 3 shows  $\tau_{\text{eff}}$  changes caused by PID tests in which a positive bias of +1000 V was applied. In this case, the  $\tau_{\text{eff}}$  rapidly degrades and saturates within several minutes. This observation probably results from the surface polarization effects proposed by Swanson et al. [12], caused by negative-charge accumulation in the front  $\text{SiN}_x$  passivation films. Such negative charges attract minority carriers—holes—in the vicinity of  $\text{SiN}_x/\text{c-Si}$  interface, and, thereby, surface recombination via surface defect states is activated. The rapid degradation and the subsequent saturation are similar to the results of previous work regarding PID in front-emitter n-type c-Si PV modules [14]. The result in Fig. 3 also explains previously reported, slight degradation in RE n-type PV modules under positive bias [10]. Our both-side-passivated sample used in this study, however, tends to be substantially affected by the charge accumulation, compared to the PV modules used in the previous study [10]. This is because the passivated c-Si has a low doping density of  $10^{15}$ – $10^{16}$  / $\text{cm}^3$ , which makes it susceptible to charge accumulation in the passivation films. (Actual devices generally have a heavily doped surface region with a doping density of  $10^{19}$ – $10^{21}$  / $\text{cm}^3$ , reducing the effect of charge accumulation.)

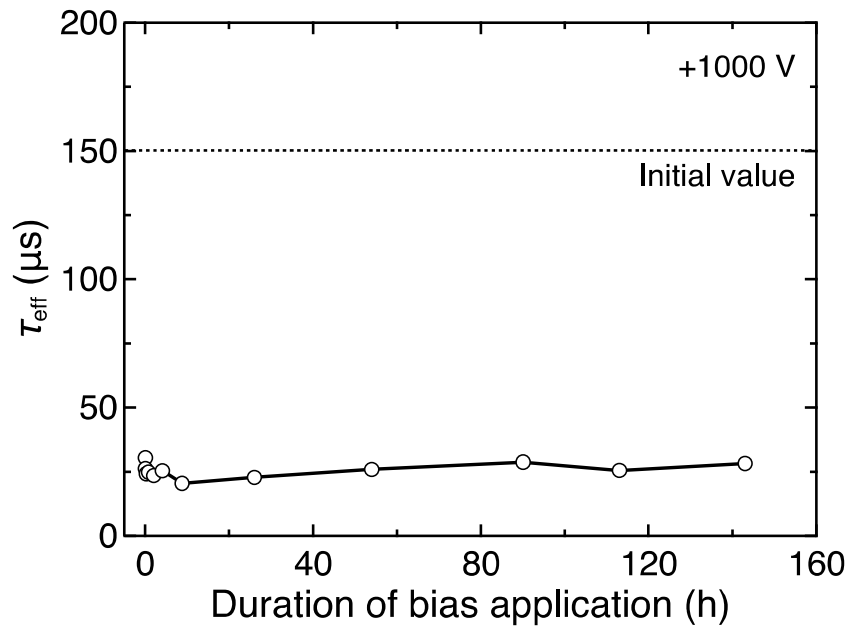
Fig. 4.

**Fig. 4.** Recovery behavior of the  $\tau_{\text{eff}}$  of the samples by the application of a positive bias of  $+1000$  V. The samples were predegraded by the PID tests in which a negative bias of  $-1000$  V was applied. The data points are the mean values for three samples. The dotted line shows the mean of the initial  $\tau_{\text{eff}}$  for the three samples.

PID-affected p-type c-Si PV modules and some kinds of n-type c-Si PV modules are known to recover from the degradation by applying an opposite bias to that applied during their degradation [7, 13, 15, 25, 26]. To evaluate such a recovery effect, we also conducted the recovery tests of the samples that were, in advance, degraded in PID tests in which a negative bias of –1000 V was applied for 177 h. After the PID tests, the recovery tests were performed by applying a positive bias of +1000 V. Fig. 4 shows the  $\tau_{\text{eff}}$  of the degraded sample as a function of the duration of the positive bias application. The  $\tau_{\text{eff}}$  of the samples

first further decreases slightly by applying +1000 V, probably due to negative-charge accumulation in the SiN<sub>x</sub> films. The samples then exhibit a slow and slight  $\tau_{\text{eff}}$  recovery; however, the  $\tau_{\text{eff}}$  after a >140-h recovery test is severely far from the initial  $\tau_{\text{eff}}$  value. The exact reason for the insufficient recovery of  $\tau_{\text{eff}}$  is still an open question. In a previous study [25], it has been reported that a positive bias leads to the outdiffusion of Na from stacking faults and leaves stacking faults without Na. On the basis of the observation, the lifetimes should be recovered in a certain extent, by the application of +1000 V. As mentioned above, our samples, however, tend to be susceptible to charge accumulation because of their low doping density. Therefore, even if Na outdiffusion occurs and carrier recombination via the Na impurity states is suppressed, our samples are instead strongly affected by the negative charge accumulation caused by the application of +1000 V, and the  $\tau_{\text{eff}}$  was strongly limited by field-enhanced recombination via surface states. This may explain the reason behind the incomplete  $\tau_{\text{eff}}$  recovery in our samples. There is also a possibility that such stacking faults remaining near the surface of the c-Si substrates behave as recombination centers and reduce the  $\tau_{\text{eff}}$ . (Note that there are no or few stacking faults before stressing. The formation of stacking faults is known to occur together with the incorporation of Na, during the application of a negative bias [23].) To understand this phenomenon, we will have to perform detailed analyses.

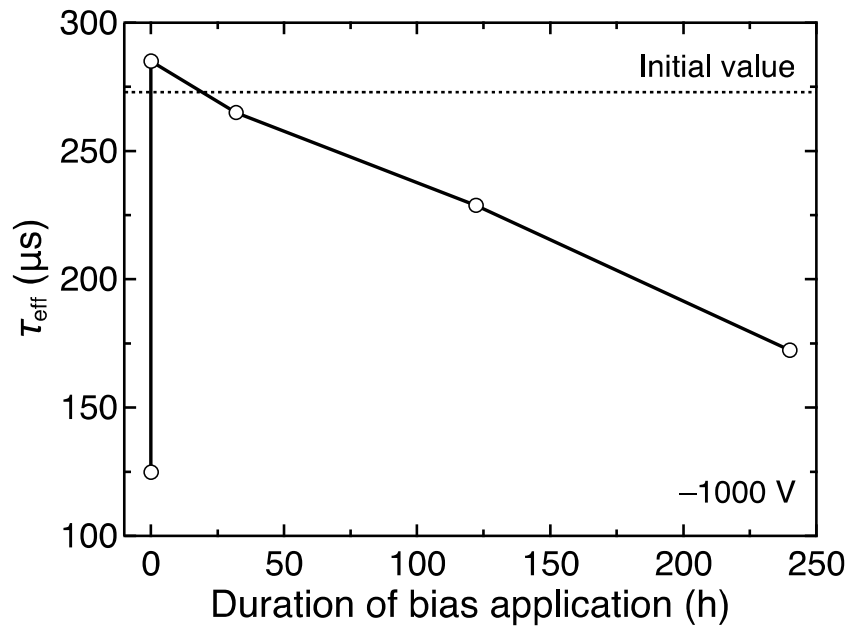
**Fig. 5.** Changes by the recovery tests in the  $\tau_{\text{eff}}$  of the degraded sample. The sample was, in advance, subjected to the PID test in which a positive bias of  $+1000$  V was applied for 30 h, and subsequently, underwent the recovery tests in which a negative bias of  $-1000$  V was applied. These data points were obtained from measurements for the one sample. The dotted line corresponds to the initial  $\tau_{\text{eff}}$ .

We also performed the recovery tests of the sample that was, in advance, subjected to PID test in which a positive bias of +1000 V was applied for 30 h. After the PID test, the recovery tests were conducted by applying a negative bias of -1000 V to the sample. The sample exhibits  $\tau_{\text{eff}}$  exceeding the initial value after the recovery tests for a minute. This recovery is most likely caused by the detrapping of negative charges accumulated in SiN<sub>x</sub> during the degradation test. The overcompensation in the  $\tau_{\text{eff}}$  may be due to the accumulation of positive charges with a density exceeding the initial charge density. However the  $\tau_{\text{eff}}$  decreases again by further application of the negative bias, which probably pertains to Na introduction into the surface region of the n-type c-Si substrate.

Finally, we discuss the tolerance of RE n-type PV modules against PID stress based on the experimental results obtained in this study, as well as our previous work [10]. The rapid decrease in  $\tau_{\text{eff}}$  under a positive bias application, originating from charge accumulation in a surface SiN<sub>x</sub> layer, will take place also in the RE n-type cells of out-door PV modules. We have, however, separately confirmed quite small performance deterioration of RE n-type PV modules under a positive-bias application [10]. Furthermore, this PID can be easily recovered by applying an opposite bias, as demonstrated in Fig. 5. We thus expect that the
